Manhole Inspection Summary

Manhole # S29Q__012MH

Location Address: **611 Ridgley St**

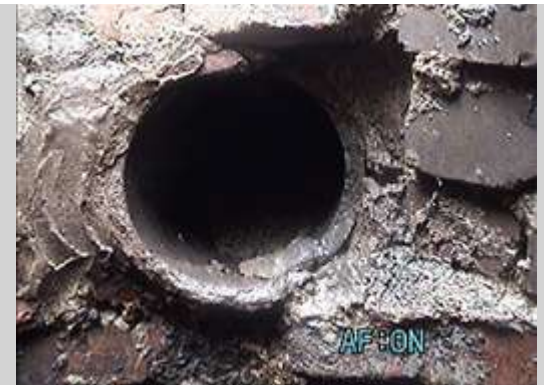
3 O'Clock Inflow

6 in. Circular Gravity Sewer
Pipe In @ 3 O'Clock

Pipe Height: **6** (in.) Rod and Bar (Angled)
Pipe Material: **Clay** ☐ Pipe Lined
Invert Depth: **2.45** (ft.) Flow Characteristics: **None**
Deposits: ☒ None ☐ Mud ☐ Sludge ☐ Debris ☐ Grease
Silt Depth: **0** (in.) Deposits Extent:
Infiltration: **None** Pipe Seal Cond: **Sound**

Connects To: **Stub connection / abandoned**

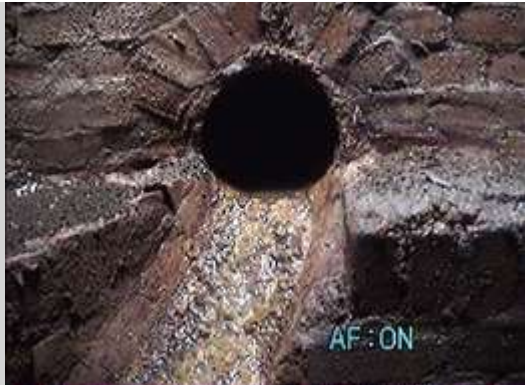
6 O'Clock Inflow

8 in. Circular Gravity Sewer

Pipe In @ 6 O'Clock

Pipe Height: **8.4** (in.) Rod and Bar (Angled)

Pipe Material: **Clay** ☐ Pipe Lined

Infiltration: **None** Pipe Seal Cond: **Sound**
